Heritage at **Risk**

South East Register 2016

South East Summary 2016

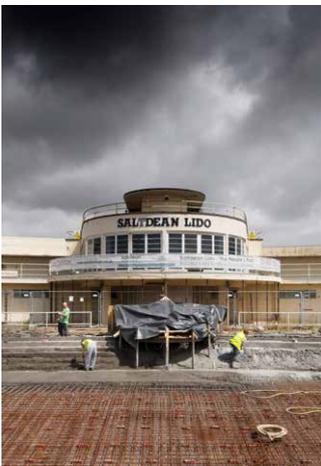
Saltdean Lido **Brighton & Hove**

Saltdean Lido, Brighton & Hove, was built in 1938. The progress made in reducing risk to the Lido, this year, is a testament to the tremendous work put into reviving this iconic temple to healthy living, by the Community Interest Company (CIC) which was set up to save it. Saltdean Lido CIC was formed in 2014, born from the ‘Save

They have already been tremendously successful in their fundraising efforts to secure a pot of money to allow the building to be repaired. The reinforced concrete of the buildings has suffered from a lack of maintenance and the effects of a marine climate, whilst the two pools

Lido of 1938, by RWH Jones in Moderne style. It is closed and suffering from a maintenance backlog and there is a particular deterioration of its reinforced concrete and the metal-framed windows. A Community Interest Company has a 60 year lease and is developing plans for its repair and reuse. Planning consent was granted in December 2014 for the repair and restoration of the pool and outdoor area. Works to restore this area are underway. Funding towards the cost of the work has been awarded by the Heritage Lottery, Coastal Communities and Social Investment in Business funds.

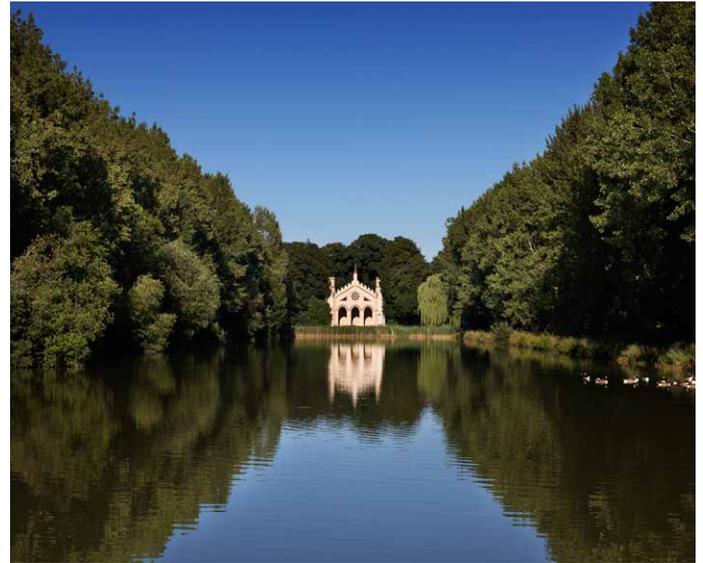
Gothic Temple **Shotover Park, Oxfordshire**

The Gothic Temple at Shotover Park in Oxfordshire was built in 1740 as an open loggia with a plain tiled roof and plaster vaults with Gothick detailing. We are delighted to be able to remove it from the South East Heritage at Risk Register this year. This follows a comprehensive programme of repairs to the folly, which sits in a landscape garden. The repairs were funded by Natural England, through their Environmental Stewardship Scheme (now superseded by the Countryside Stewardship Scheme), and the owner's professional team were advised by architects and surveyors from Historic England. Work was completed in late 2015 and is an excellent example of partnership working between both bodies.

The folly had fallen into a state of disrepair through a lack of maintenance over a number of years, but when ownership arrangements changed, the Estate Trustees sought funding to improve the condition. The folly has particularly fine stuccowork which has now been restored through the work of skilled craftspeople, using traditional plasterwork repair techniques and historically

correct materials. The roof has also been repaired, and the surrounding vegetation controlled. Always designed to face the house at Shotover along the length of an ornamental pool, it is now reflected in all its glory in the waters again.
