Heritage at **Risk**

Historic England

Yorkshire Register 2016

Yorkshire Summary 2016

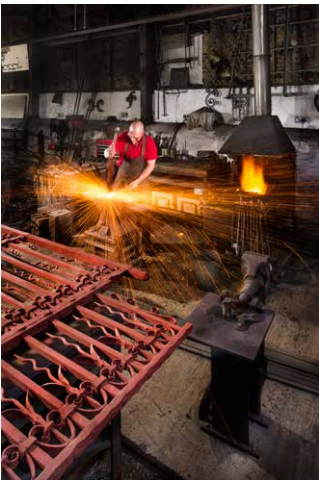
Oakes Park **Norton, Sheffield**

Skilled blacksmith Daniel Liggins repaired these ornate wrought iron gates from Oakes Park near Norton, Sheffield. We provided grant-aid to support the rescue of the grade II* listed gates and gate piers which date from the early 18th and 19th centuries. The works, which also included tree management and the

replacement of ornamental urns and finials, have enabled their removal from the Heritage at Risk Register this year. The grade II* registered park and garden remains at risk.

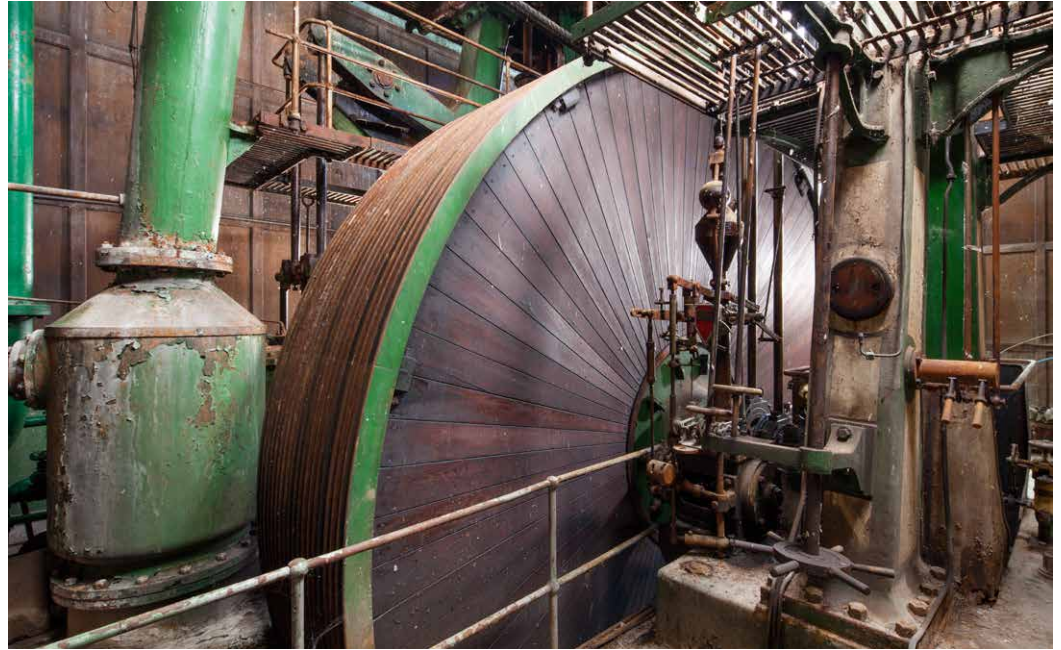
Waterloo Mill Engine House **Silsden, Bradford**

The most remarkable part of Waterloo Mill is also the most recent addition. The mill was built in the 1860s, but a new engine house was added in 1916 to contain a second-hand 1896 Scott & Hodgson inverted vertical cross compound steam engine, which was working until 1977. Most engines were sold for scrap when they became redundant so this one, with its apple green livery, is the last of its type. The baroque design of the engine house, its panelled interior lit by electricity from the start, is an eloquent testimony to the pride of Taylor Brothers, woollen yarn spinners, who operated the mill.

We are supporting the repair of the engine house with grant-aid. Work will include structural repairs to prevent

the collapse of the concrete flat roof, a new asphalt covering and repairs to the masonry and windows. The panelling will be repainted. A new staircase will give improved access to the interior, allowing visitors to savour the oily majesty of this unique survivor from the glory days of the West Riding woollen industry.
