Heritage at **Risk**

Historic England

East of England Register 2017

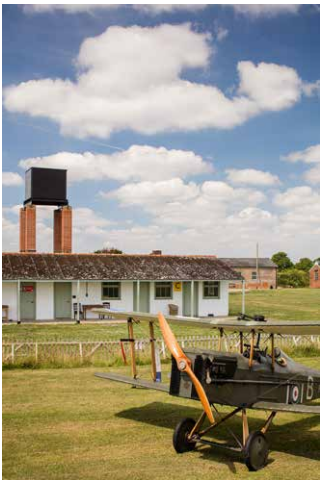
Stow Maries **Maldon, Essex**

Of the original 47 buildings on the aerodrome, 24 survive. Through outstanding volunteer effort and fundraising, repair of some of the buildings began in 2007, work which included the creation of a museum in the Squadron Offices. In 2012, all 24 of the surviving buildings were

listed at grade II* and more than half of the buildings, some in a very perilous condition, were put on the Heritage at Risk Register. A wide range of building types is represented, including the now repaired Pilots' Ready Room and Water Tower (see image).

In 2013 this historic site was purchased by Stow Maries Great War Aerodrome Ltd, a charity set up for the purpose of preserving it for public benefit and education. Since then, Historic England has supported the charity with expertise and grants for a programme of repairs. This is on-going and it will be several years yet before all the buildings are in a safe condition and the site as a whole can be removed from the Register.

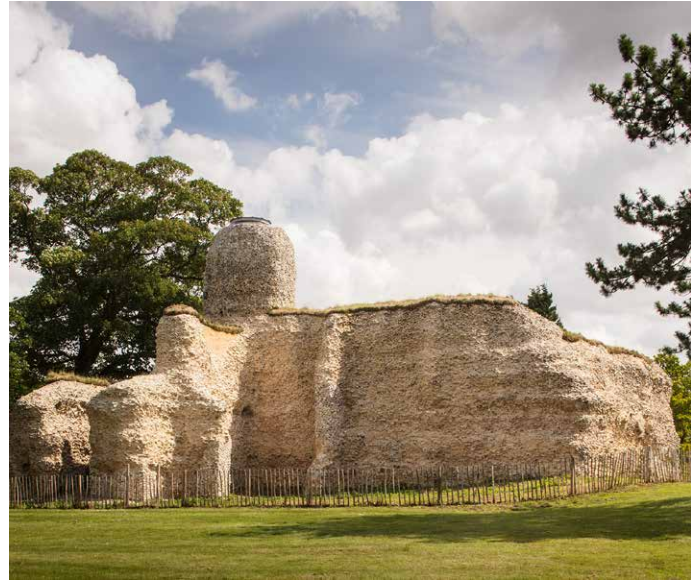
Walden Castle went onto the Heritage at Risk Register because uncontrolled vegetation growth and exposure to the elements were causing decay and collapse of the rubble walls. With advice and grant support from Historic England, in 2013 Uttlesford District Council embarked on a programme of stabilisation and repairs, now complete, which included protecting the walls with a ‘soft capping’ of carefully selected grass and other plants. As a result,

Walden Castle came off the Register in 2017. Landscaping work and improved interpretation will complete the scheme, making the castle once again fully accessible to the public.
