Heritage at **Risk**

Historic England

Yorkshire Register 2017

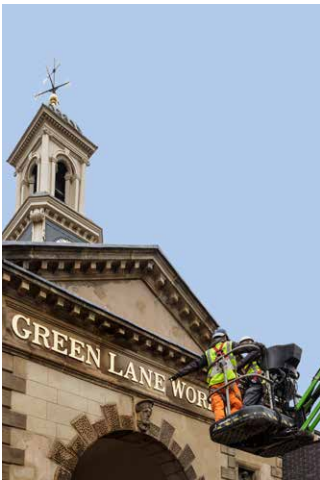
Green Lane Works **Sheffield, South Yorkshire**

For many years the imposing grade II* listed gateway to Green Lane Works has been hidden behind hoardings and the elegant clock tower has been obscured by a complex mesh of scaffolding that was put in place to prevent its collapse. Luckily, Leeds-based developer CITU recognised the potential

Now, after months of painstaking repair and conservation work, the scaffolding has been removed and the ornate clock tower, with its unusual cast iron scrolls and gilded weather vane, is once again a landmark on the city's skyline.

The clock has now been fully repaired with grant so that it not only displays the correct time, but will chime the hour for the residents of Kelham. The gilded triumphal arch with its bronze relief panels depicting Art and Industry will once again be the main point of entry to a thriving, vibrant site where characterful historic buildings now sit comfortably alongside innovative new dwellings. Grant has also been used to repair masonry and replace windows and rainwater goods.

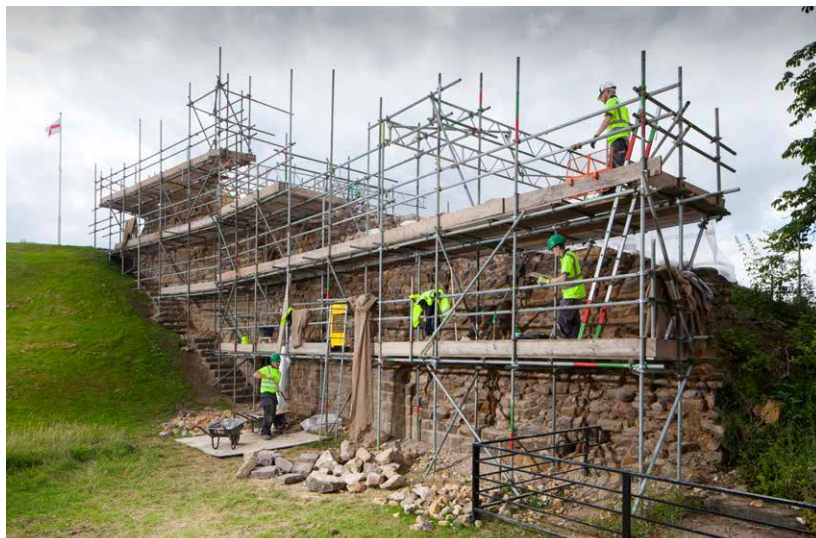
Pontefract Castle is one of the last great monuments on the Yorkshire Heritage at Risk Register. The Norman motte and bailey castle is closely associated with royalty, and Charles I paid for significant repairs early in his reign. The Royalist garrison survived three prolonged sieges before finally surrendering in 1649 when parts of the building were dismantled by the ruling Parliamentarians.

One of the most unexpected and exciting finds during the project has been the discovery of the inner bailey gatehouse and drawbridge pit. We are currently funding excavation and repairs to the Sally Port that will allow further access for visitors to the site.

Historic England is now in the final year of more than a decade of repairs. Working with the owners – Wakefield Council – we have provided significant funding to secure the consolidation of the structure. The initial proposal to make the structure safe and more accessible has become the multi-million pound Heritage Lottery Fund backed ‘Key to the North’ project, improving visitor experiences with new paths, interpretation and a purpose-built visitor centre. There has already been a big increase in visits to the castle through major events, volunteer programmes and a number of community-based archaeology projects.
