Causewayed Enclosures

Introductions to
Heritage Assets

May 2011

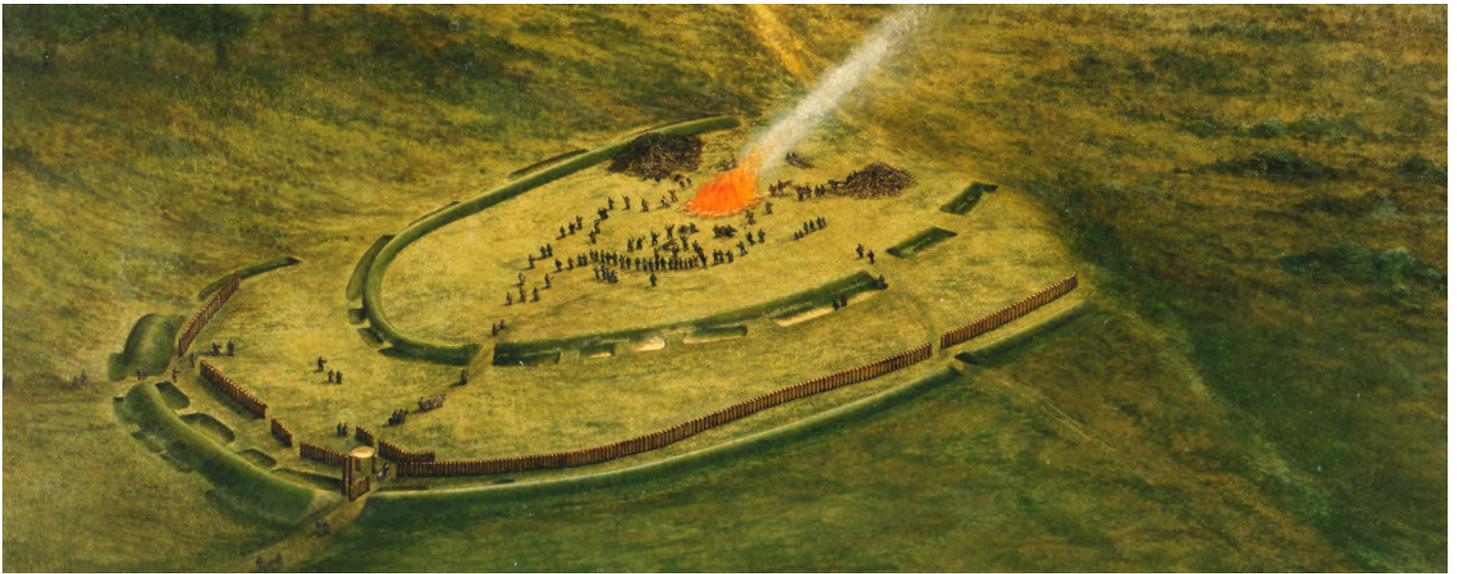
Fig. 1. Reconstruction based on the excavated evidence from the causewayed enclosure at Orsett, Essex.

Archaeologists have named this type of monument based on the distinctive form of the earthworks defining the perimeter: the ditch, and to a lesser extent the bank, were discontinuous, comprising short stretches of varying length separated by causeways of intact ground (Figure 1). They are not the only form of Neolithic enclosure: a few with continuous earthworks have proved to be of similar date. Nearly 80 causewayed enclosures are now known in the British Isles and more examples certainly await discovery, but they will undoubtedly remain an extremely rare type of monument. The majority of those currently known are found in England south of the River Trent, but a few outliers have been identified in Wales, Scotland, Ireland and Cumbria (Figure 2). Curiously, eastern Yorkshire, much of which has been well studied through aerial photography and is known to possess a wealth of early Neolithic remains, has not yet produced a single example of a classic causewayed enclosure. At Carn Brea in Cornwall and other areas where hard rocks dominate the uplands, discontinuous drystone walls without ditches (called 'tor enclosures') may have performed a similar purpose to the causewayed perimeters elsewhere.

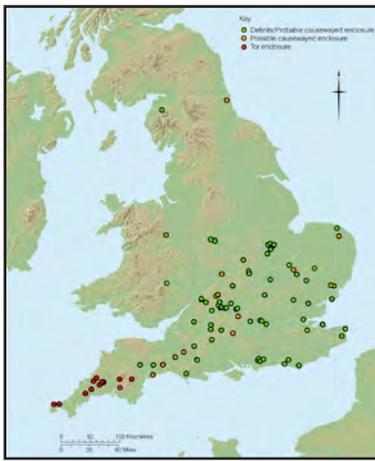
Fig. 2. Distribution of causewayed enclosures in England: a few more exist elsewhere in the British Isles and new examples still occasionally come to light.

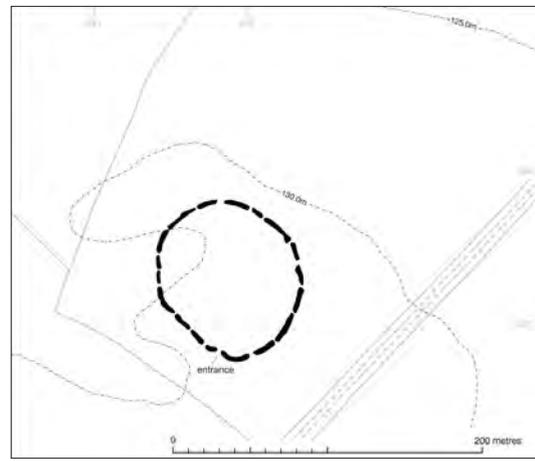
Fig. 3. The causewayed enclosure at Burford, Oxfordshire, whose ditch has been plotted from aerial photography, exemplifies this form of monument at its simplest.

Most causewayed enclosures are oval in plan, with some sufficiently close to a circle to suggest that the builders were aiming for this basic shape. Most comprise a single circuit of discontinuous bank and ditch (Figure 3). Some have two or three concentric circuits; in many cases, it remains uncertain whether all were created or used at the same time. Where double lines of ditch are closely spaced and run precisely parallel to each other, these may have provided material for a central bank, the two ditch circuits thus forming a single boundary. Most circuits are between 0.4 hectares and 3.0 hectares in internal area, but the largest is around 10 hectares. In some cases, perimeters incorporate natural barriers such as rivers and steep slopes, while a few (often called cross-ridge dykes) span the necks of spurs and promontories.

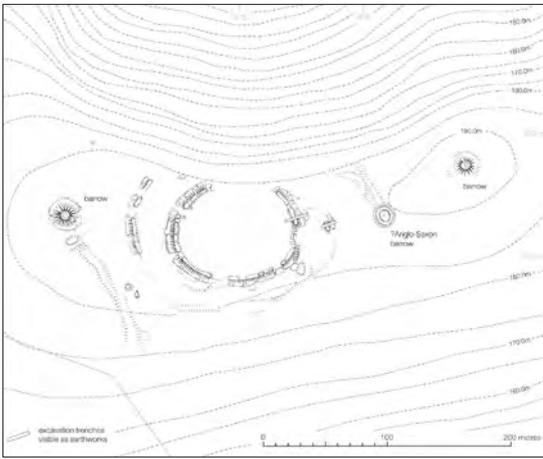
Fig. 4. The well-preserved causewayed enclosure on Combe Hill, East Sussex, seems to have been sited at the head of the valley, a dramatic topographic feature.

Most causewayed enclosures on higher ground are centred just off summits so that they have a distinct orientation, perhaps signifying a link with a particular area of lower-lying land. Some occupy striking landforms (Figure 4), while the so-called 'tor enclosures' of the South-West have been named because most surround or incorporate these prominent landmarks. Many of the examples known through aerial photography are in lower-lying locations, frequently close to rivers or streams. Here too, enclosures were often sited on sloping ground, so that in some cases, parts of the circuit were seasonally flooded.

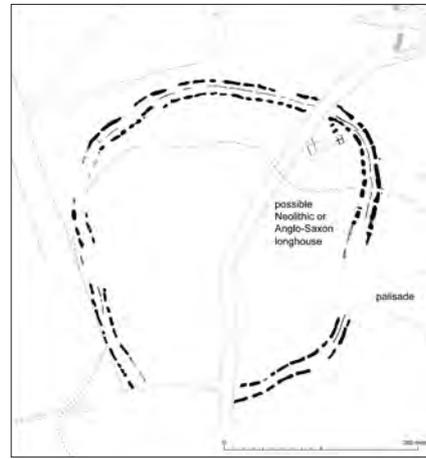
Fig. 5. Permanent settlement does not seem to have been characteristic of causewayed enclosures; the possible Neolithic longhouse at Freston, Suffolk, is unique.

Causewayed enclosures usually contain a sparse scatter of pits and post-holes. They were probably not permanently occupied (Figure 5). Modern investigations have supported early interpretations which compared them to fairgrounds: places where dispersed social groups could gather episodically on neutral ground to reaffirm their sense of community through a range of activities including feasting, crafts, and the performance of rituals associated with death. On occasion, certain enclosures were briefly used for defence (Figure 6). But not all enclosures hosted the same activities and sometimes the evidence is difficult to interpret. Some experts see the creation of the monument as an end in its own right, the construction project itself serving to give the builders a common focus. This may explain why some enclosures seem to have been deliberately demolished – the banks being pushed back into the ditches – immediately after they were built.

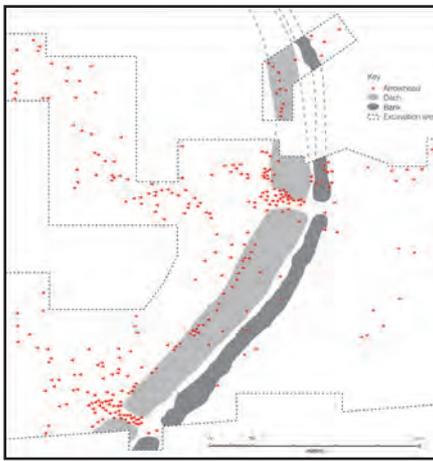
Fig. 6. The distribution of flint arrowheads excavated outside the entrance to the causewayed enclosure on Crickley Hill, Gloucestershire, clearly testifies to an attack.

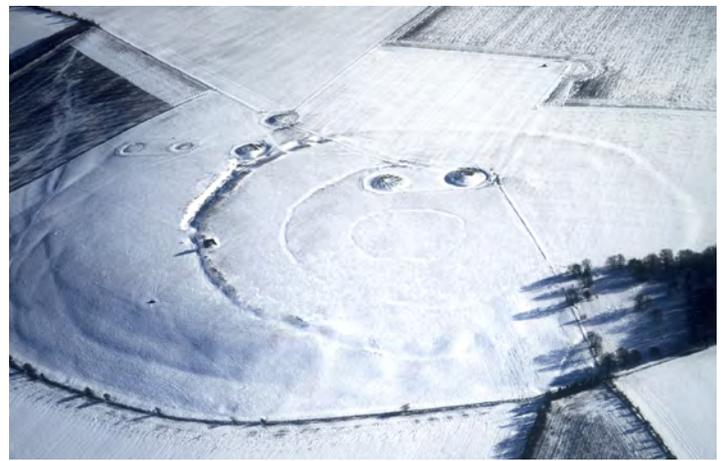
Fig. 7. The complex enclosure on Windmill Hill, near Avebury, Wiltshire, has dominated thinking about this type of monument for nearly a century.

The enclosure at Windmill Hill, near Avebury in Wiltshire, which has been extensively excavated, has three widely-spaced circuits which were very probably constructed over a period of between 5 and 80 years in sequence from inner to outer. They were eventually used together to define three separate, concentric spaces where different kinds of activity took place. Here, and elsewhere, the outermost circuit was a considerably bigger earthwork, suggesting a change in the function of the enclosure.

In the 1920s, Alexander Keiller and O G S Crawford excavated a causewayed enclosure on Windmill Hill, research which was eventually published by Isobel Smith in 1965 (Figure 7). A search for comparable sites began and in 1930, based partly on Crawford and Keiller's work, E C Curwen correctly identified ten causewayed enclosures, all but one surviving in earthwork form on the chalk hills of southern England. Curwen inferred from this, and the comparable distribution of surviving long barrows, that high ground was favoured for Neolithic settlement, while the lowlands remained marshy and blanketed in impenetrable woodland. The number of certain or probable

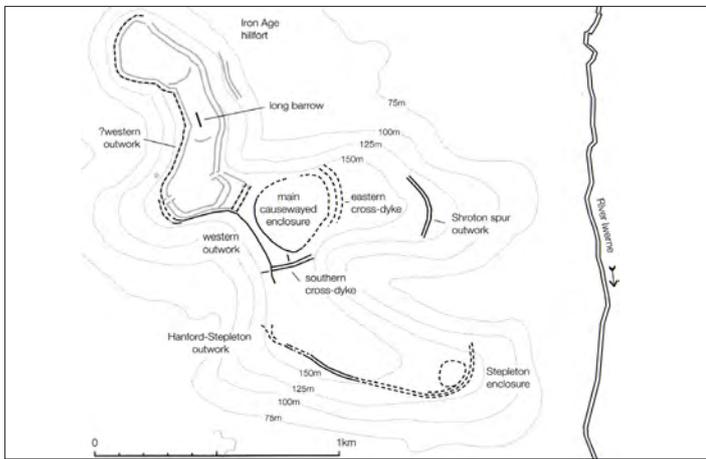
Fig. 8. The extensively researched complex of two long barrows, two causewayed enclosures and numerous causewayed outworks on Hambledon Hill, Dorset, is unique.

Many of the key excavations from which the interpretations of causewayed enclosures derive have taken place on the chalk hills of southern England, amongst the most important being those at Windmill Hill in Wiltshire, Hambledon Hill (Figure 8) and Maiden Castle in Dorset, and Whitehawk Camp in East Sussex. Excavations of low-lying enclosures, such as those at Etton and Haddenham in Cambridgeshire, where waterlogged conditions sometimes preserve organic materials, have offered different insights into the complex use of these monuments. Even so, relatively few examples have been extensively excavated using modern techniques, so much remains unknown.

Causewayed enclosures were associated with two other types of early Neolithic monument: long barrows and cursuses. At Hambledon Hill, a long barrow was built in the space between the main circuit and one of the outlying causewayed cross-ridge dykes, while another occupied a spur on the opposite side of the enclosure. These associations reinforced the excavators' view that the causewayed enclosure was linked with ritual practices surrounding death. At Maiden Castle, the causewayed enclosure is overlain by the tail of an extraordinary long mound, also of Neolithic origin. Recent scientific dating shows that causewayed enclosures and cursus monuments overlapped chronologically, and in some cases physically (Figure 9).

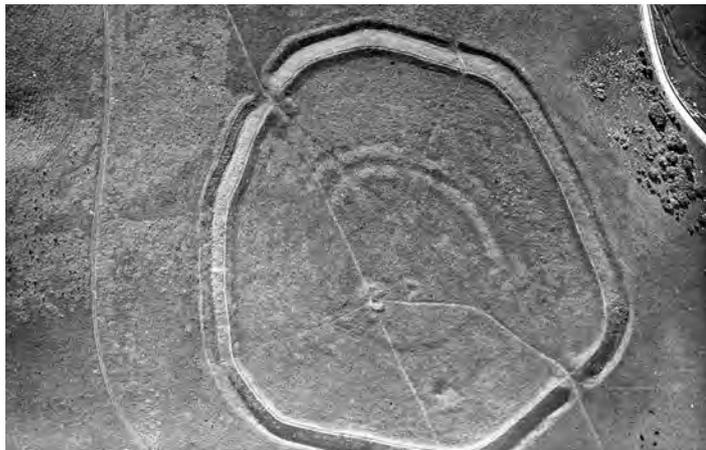
Fig. 10. The Trundle West Sussex, as photographed in 1928. An Iron Age hillfort surrounds and partly overlies a larger causewayed enclosure with perhaps as many as five circuits.

Certain Iron Age hillforts were superimposed upon causewayed enclosures, around 3,000 years after the causewayed enclosures were built, leaving short stretches of the Neolithic earthworks visible (Figure 10). It is possible that future excavations may reveal causewayed enclosures directly underlying, for example, medieval castle defences. Such co-locations can again probably be explained as a reflection of a shared preference for hilltops, and do not necessarily offer insights into the motivations of the later builders. In a few cases, aerial photographic evidence suggests that Iron Age or Romano-British farming settlements incorporated the earthworks of causewayed enclosures into their perimeters, testifying to the longevity of the Neolithic earthworks. The superimposition of later banks may well

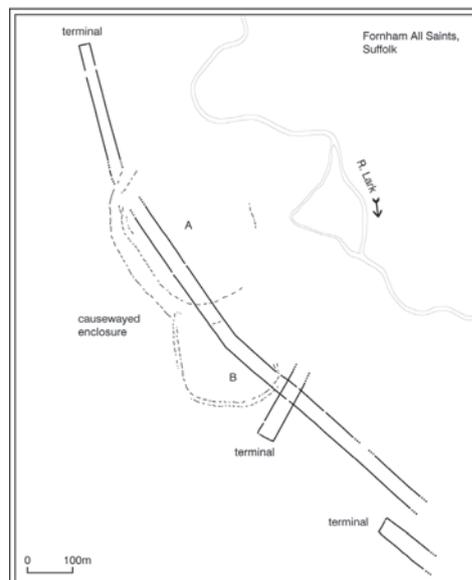
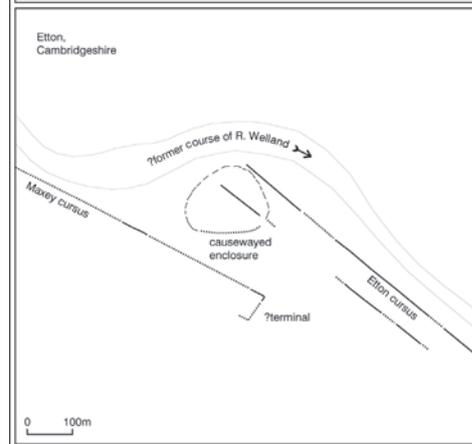
Fig. 9. At both Fornham All Saints, Suffolk, and Elton, Cambridgeshire, aerial photography has revealed causewayed enclosures with several cursus monuments in close proximity.
