Ancient Monuments Laboratory  
Report 63/94

ENVIRONMENTAL MONITORING AT  
BATTLE ABBEY, EAST SUSSEX

Barry Knight BA MSc DPhil CChem MRSC

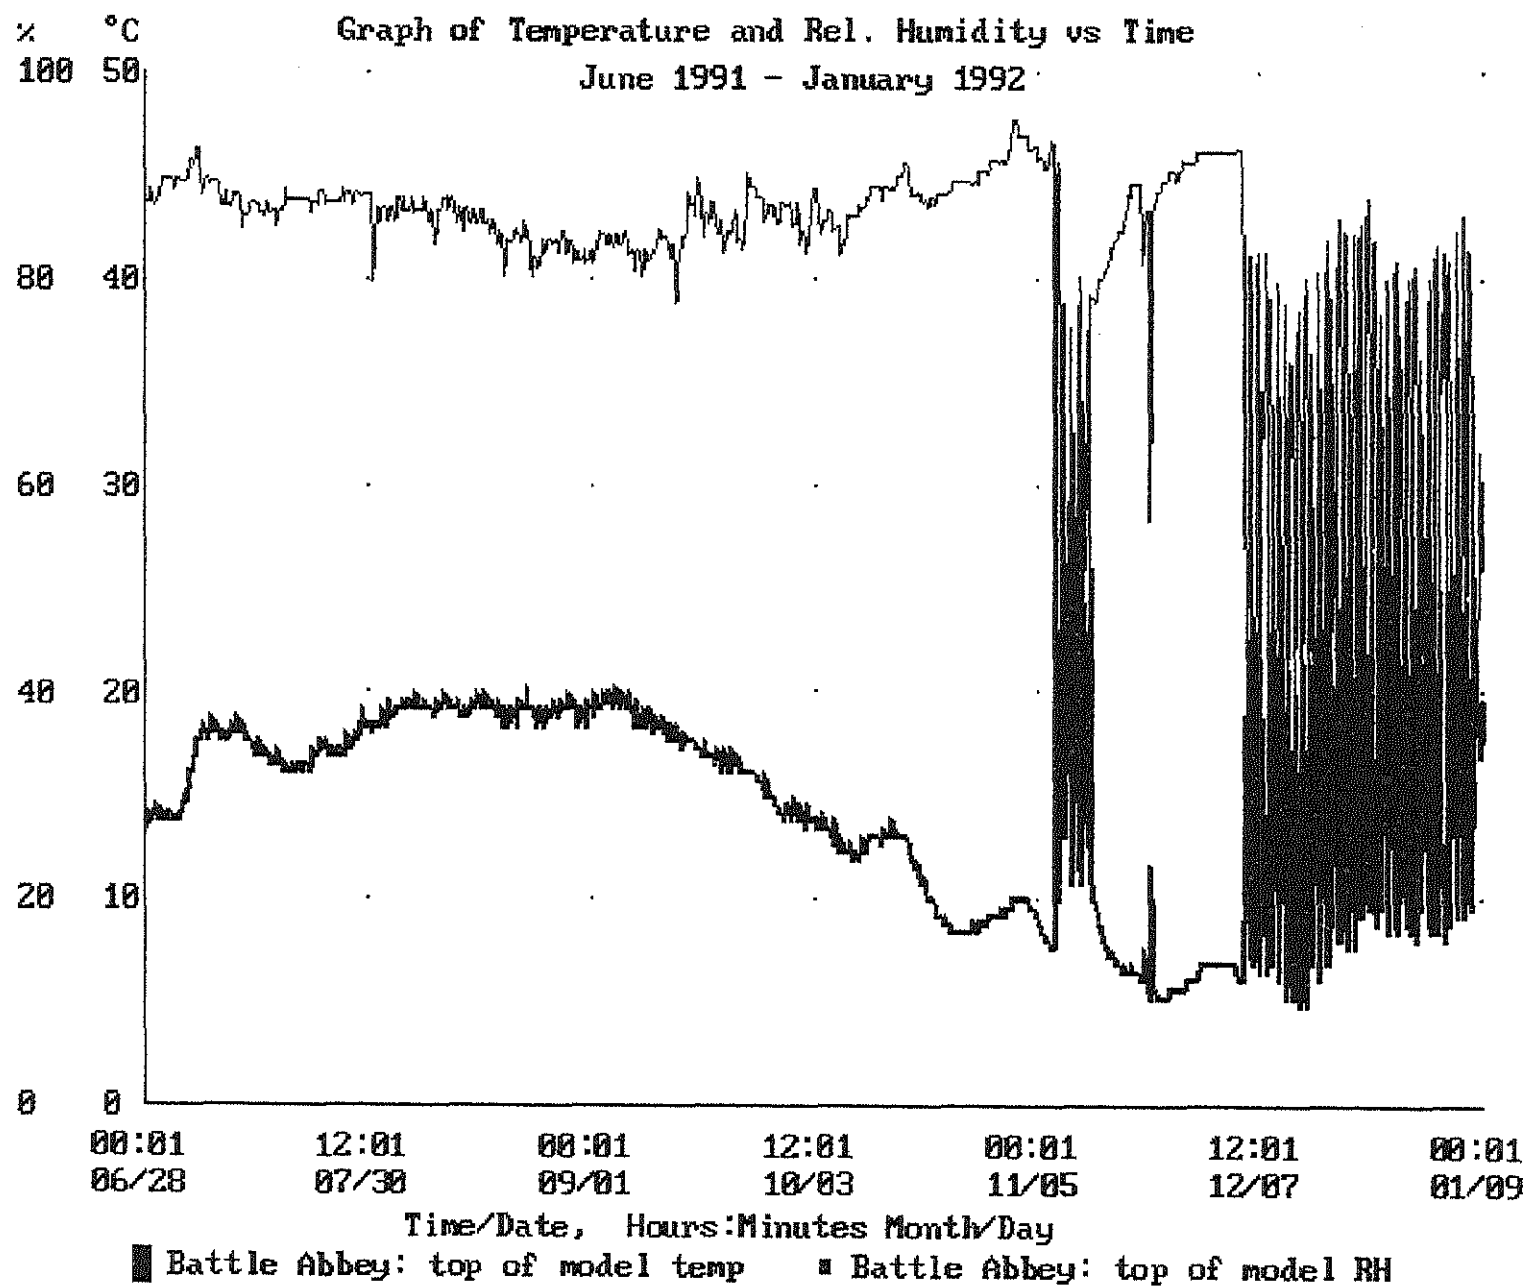
Graph 1 shows the conditions in this room before the display was installed. During the summer of 1991 the heaters were not operating and the temperature and RH are fairly

steady, averaging 18.0° and 86.4%, with a daily fluctuation of about 1° and 2%. The violent fluctuations during November and December 1991 are the result of the heating being turned on at full power while workmen were installing the exhibition. Since the exhibition opened in April 1992 the fluctuations have been smaller, but still larger than before the heating was in use. (Graphs 2 & 3). The control of the temperature does not appear to be very precise, and the fluctuations in relative humidity, though partially caused by external weather conditions, are correspondingly large. Graph 4, which compares the temperature in room 1 with that inside one of the cases, shows that the temperature goes out of control from time to time -- this needs investigating.

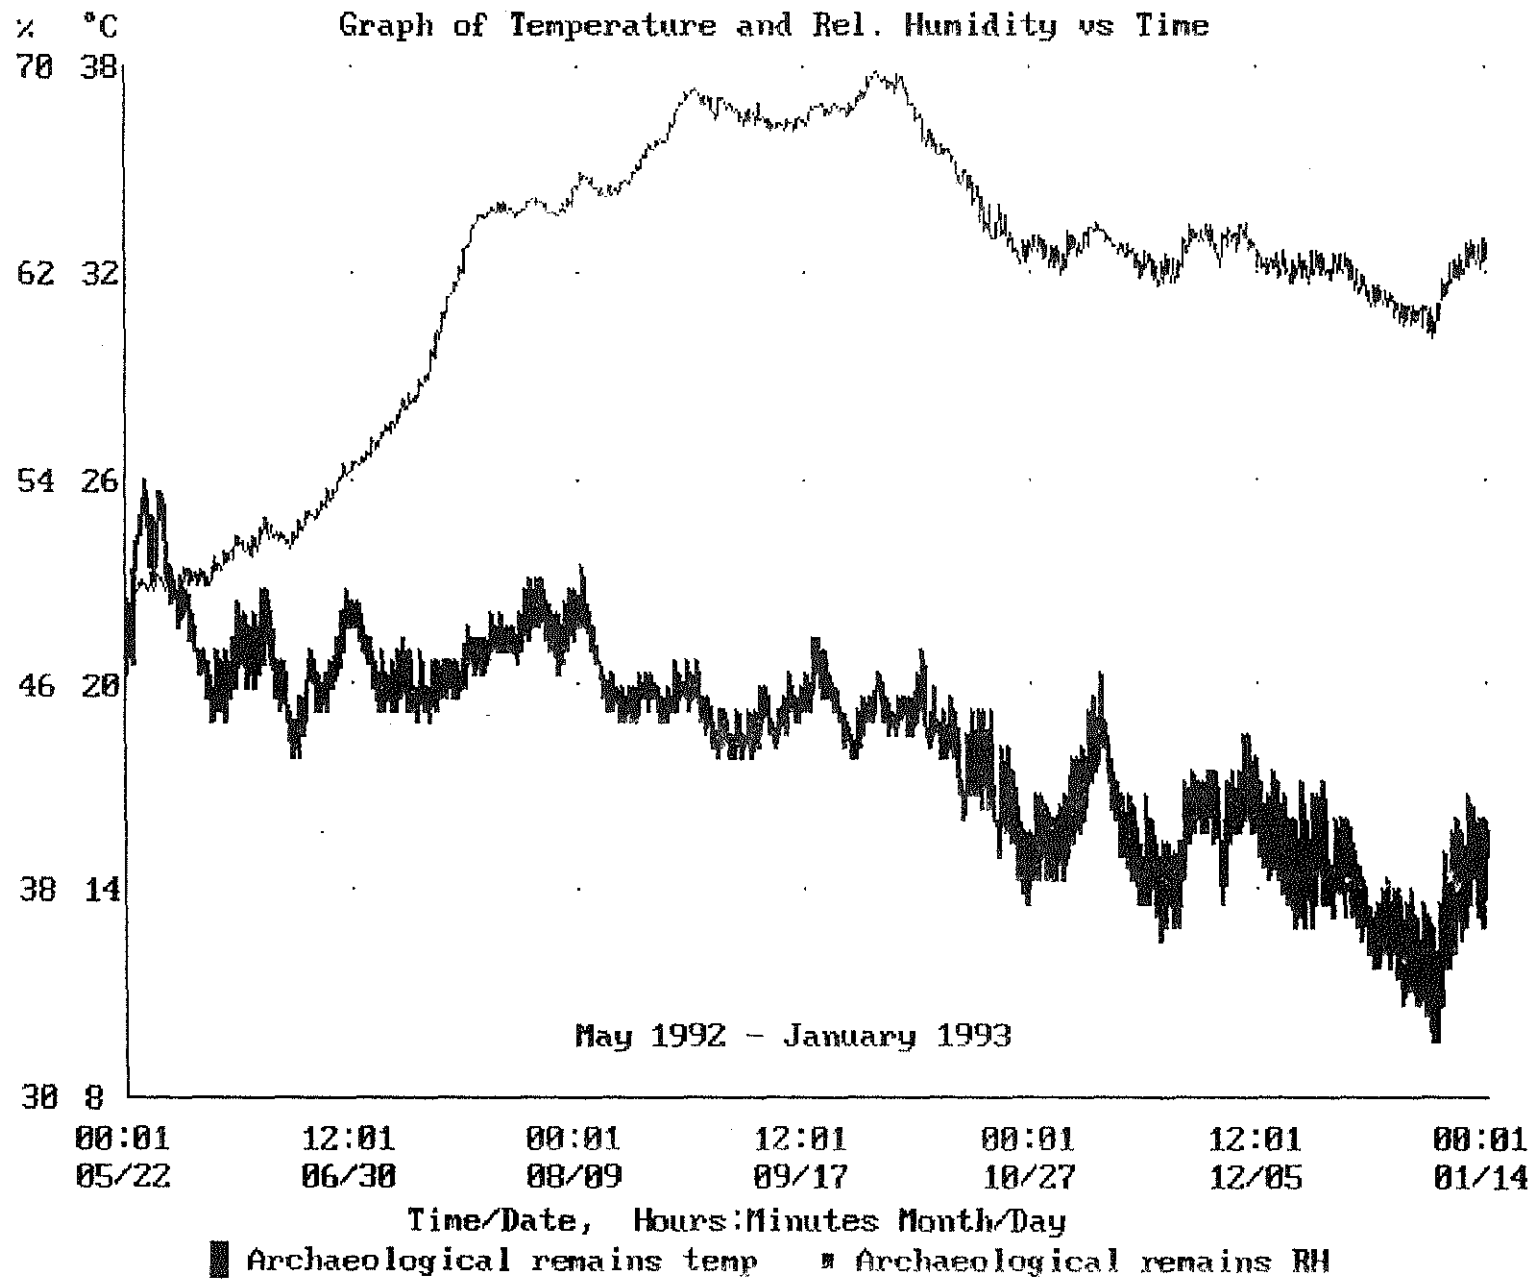
This case contains excavated objects and their modern equivalents. It is constructed of oak-veneered MDF, and it was feared that this might emit formic acid which would attack the artefacts. However, small coupons of silver, copper and lead which were placed in the case have remained untarnished for nearly two years, which suggests that this is not a serious problem. As this case contains excavated iron objects it is desirable that its RH should be as low as possible. Initially it was filled with 3kg of desiccated silica gel, which reduced the RH to about 40% (Graph 9). However, the RH then drifted upwards, reaching 70% in the summer of 1992 (Graph 10) before drifting downwards to about 56%

the following winter. The RH again rises to around 70% in the summer of 1993 before falling to around 50% in the winter (Graph 11). Desiccated silica gel was placed in the case in March 1994; it should be changed at least every six months if it is to be effective.

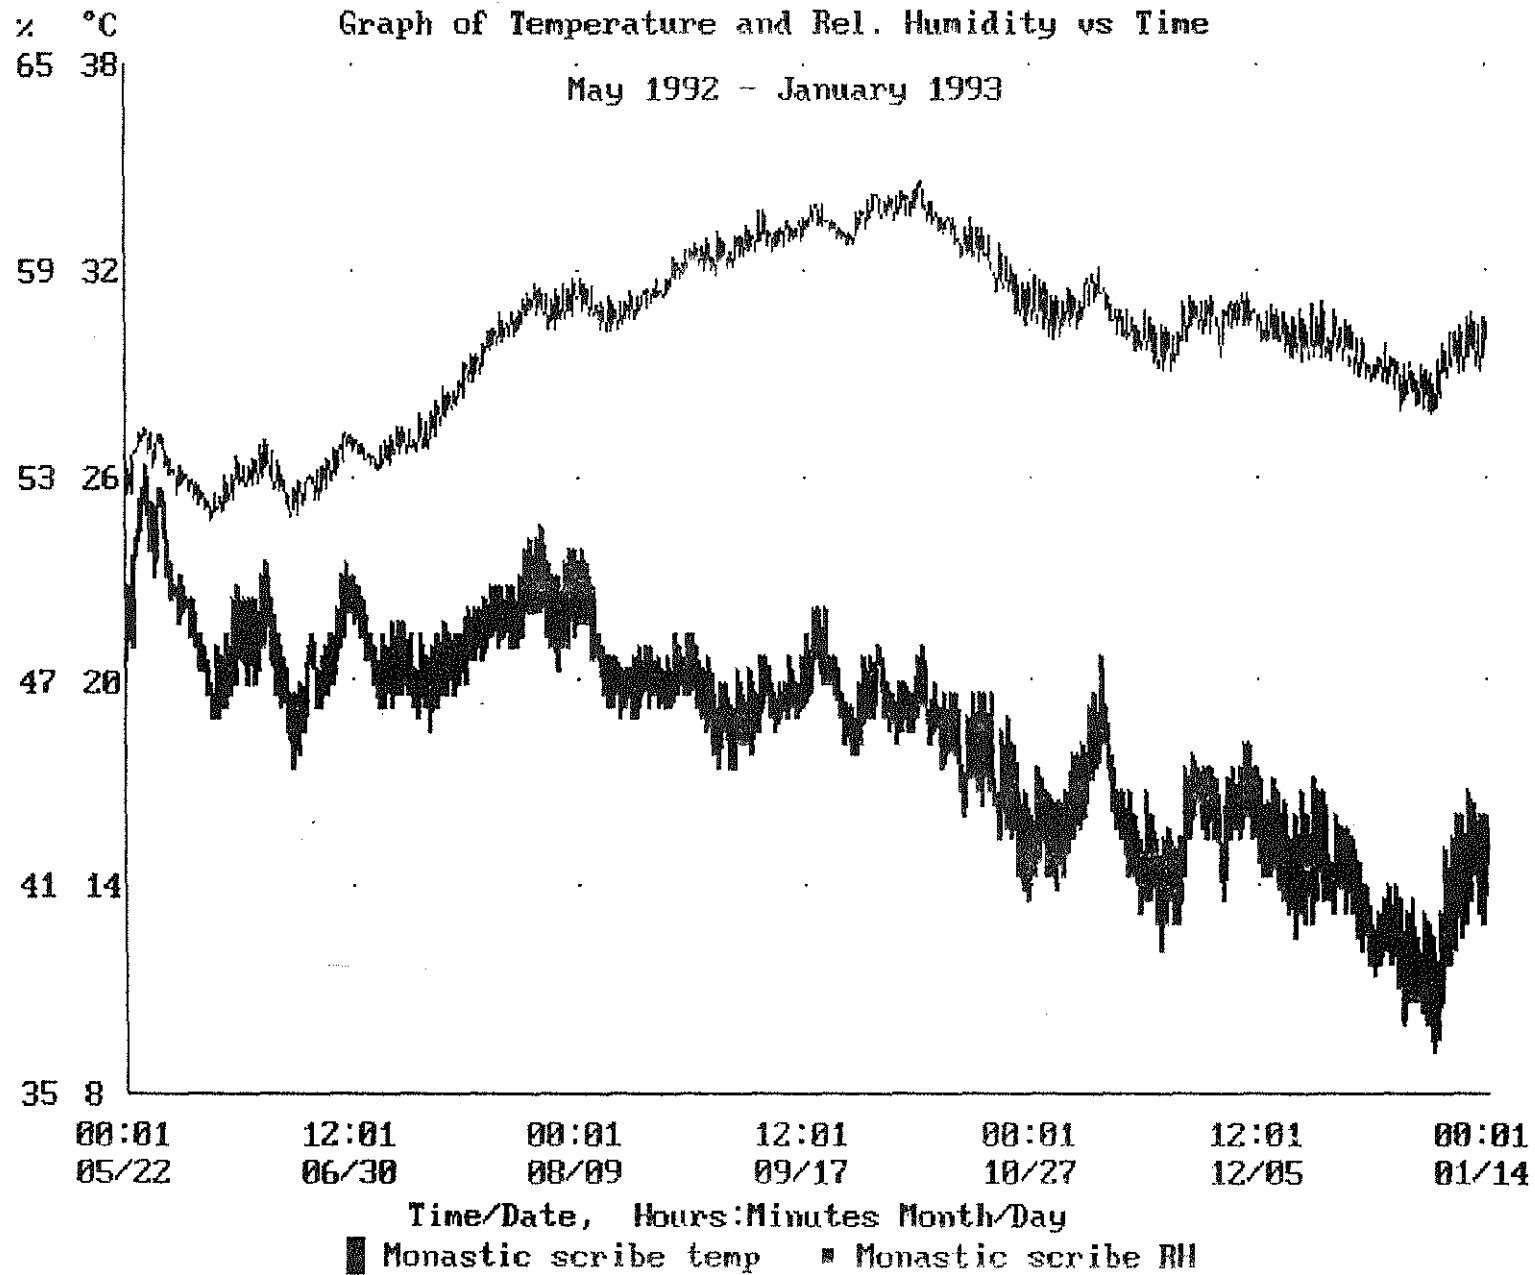
This case contains bone parchment prickers and copper alloy book clasps. It should be buffered to 60 +/- 5%: the results for May 1992 to January 1993 (Graph 12) show that this has largely been achieved. The case contains 1kg of silica gel which was not changed. Using a larger quantity of silica gel would give greater stability.

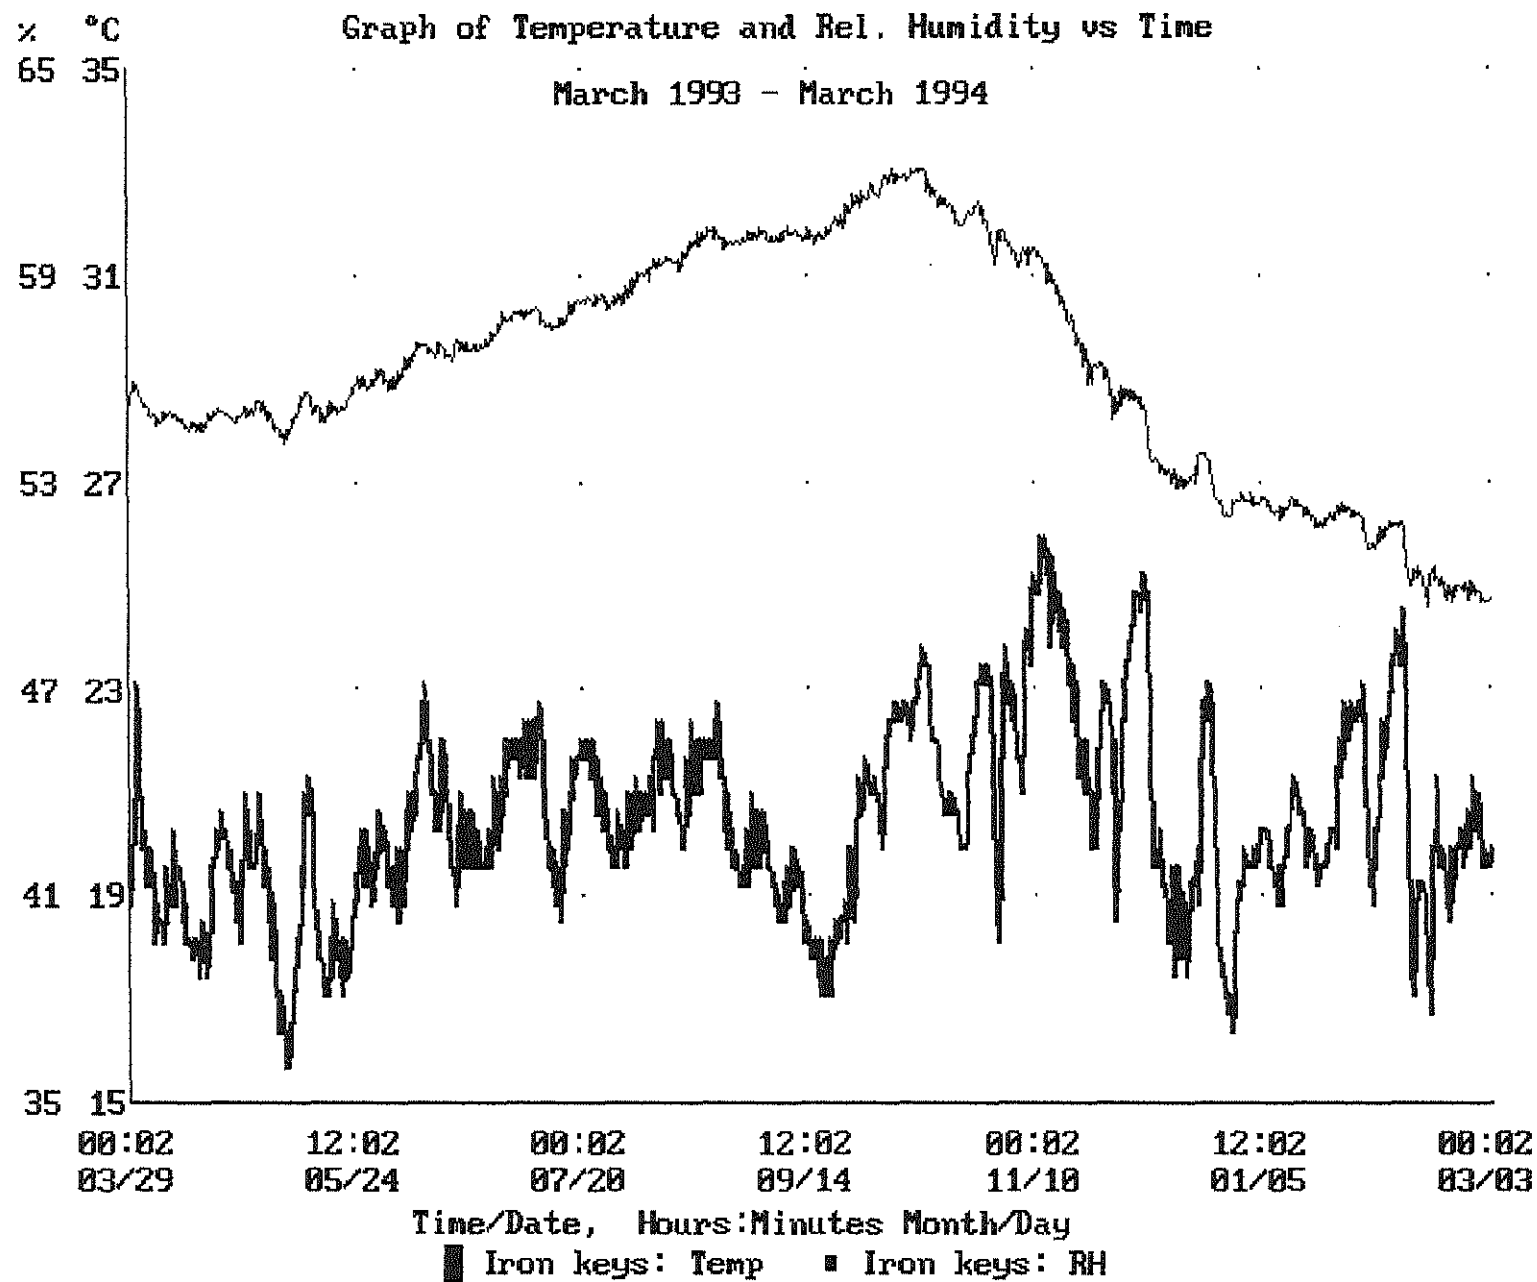
Since it contains archaeological ironwork the RH in this case should be as low as possible. Graph 13 shows that in the summer of 1993 the RH reached about 63% before falling to about 50%. 4.5kg of desiccated silica gel were placed in the case, which should be changed at least every six months.
