BUSHMEAD PRIORY (St. Neots)

Window Glass.

Site Visit 12th February 1975

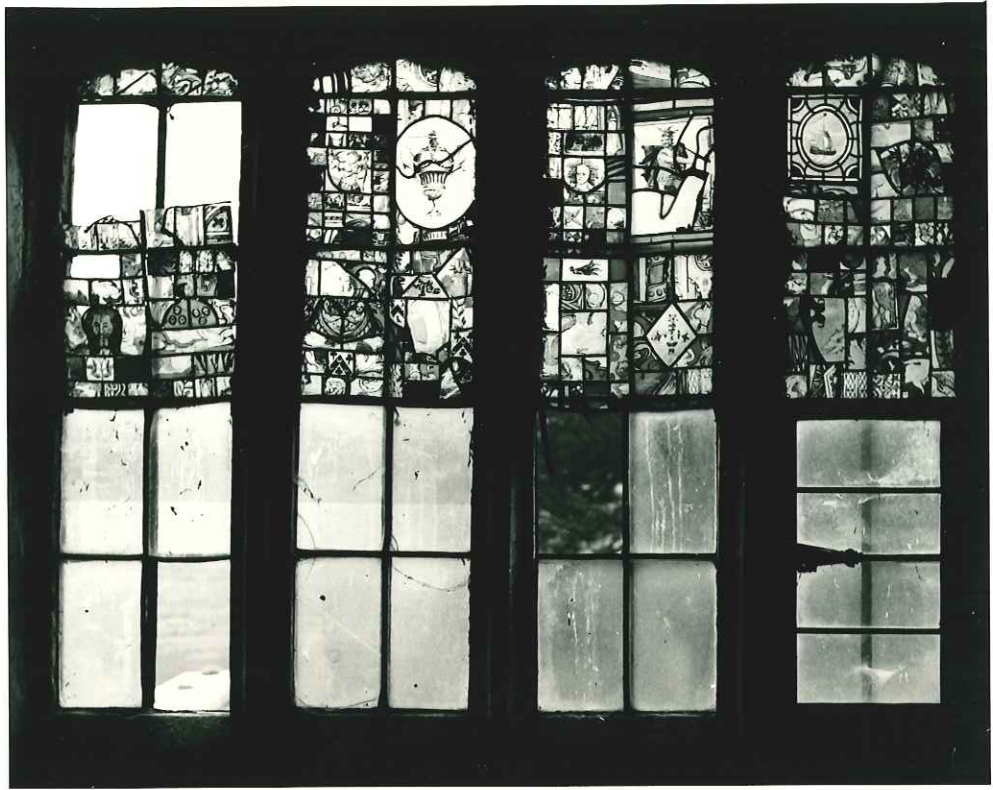
The stained/painted glass windows are on the first floor of the building. The glass itself is in comparatively good condition, having been re-leaded in Victorian times. However no attempt was made to piece similar pieces of glass together - and the whole appears as a "patchwork". Some damage has already led to the partial breaking of one of the panels (photograph 1) and the remaining lead is fragile, particularly where the lead joins the stonework.

As the Priory will require much rebuilding and reinforcing it is recommended that the four glass window panels (photographs 1-4) be removed as they stand at present and brought to the Laboratory. In the Laboratory cleaning and re-leading can be carried out. Obviously the voids thus left in the windows will have to have temporary glazing inserted to prevent further damage to the fabric of the building. When the Priory is restored the cleaned and re-leaded glass panels should be returned, but displayed in front of clear glass. I recommend that the windows as they at present stand be removed to the Laboratory as soon as possible. This should be co-ordinated so that Masons, Glazers and Laboratory Staff ~~are~~ are on site at the same time. Any great delay in the removal of these windows will without doubt lead to much more damage being caused.
