LYTHAM HALL, LYTHAM, LANCASHIRE

DENDROCHRONOLOGICAL ANALYSIS OF OAK AND PINE TIMBERS, AND LIVING OAK TREES

SCIENTIFIC DATING REPORT

Ian Tyers

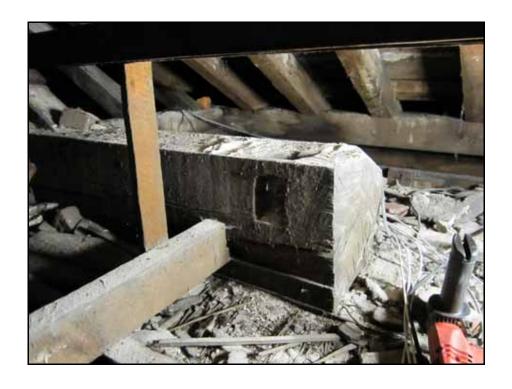
Figure 6: The T21 tiebeam end with a rafting or hauling hole. Photo Ian Tyers

One unique feature of this roof is the presence of a softwood timber bearing both a distinctive hauling or rafting hole and ownership stamps in the form of 'PR' repeated several times (Figs 5 and 7). Rafting holes are relatively widely seen in continental softwood buildings, particularly of log-cabin type and are apparently derived from the habit of forming rafts of timbers for their downstream delivery from the forests to the ports (Thomas Eising *pers comm*). Presumably such features are rare in British buildings as they were typically cut off when constructing roof tiebeams of specific lengths, or perhaps they are common but well hidden along the outside edges of the roofs. Lytham Hall's double pile-plan form and rather anomalous overlapping tiebeams may have made either their removal unnecessary, or simply provides opportunities for seeing them that are rarely presented elsewhere. A further timber that forms both the T3 tiebeam and the T4-T6 centre-beam was also noted bearing 'PR' stamps although these were not photographed. Neither of these timbers proved datable, indeed the former could not even be sampled due to its location and alignment. However there is no reason to suppose that the results obtained from the other softwoods in this roof are not indicative

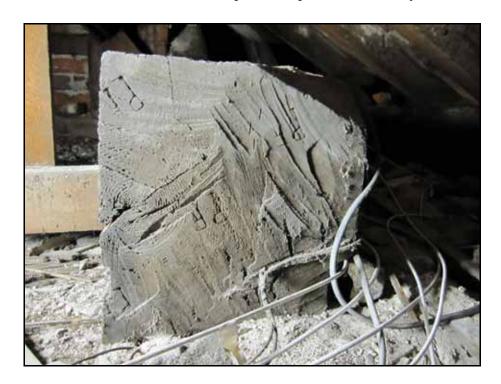
Figure 7: The T21 tiebeam end with multiple PR stamps. Photo Ian Tyers

of the source and origin of these marked timbers. The 'PR' stamp may indicate the exporter, the importer, or some other stage in their travels.

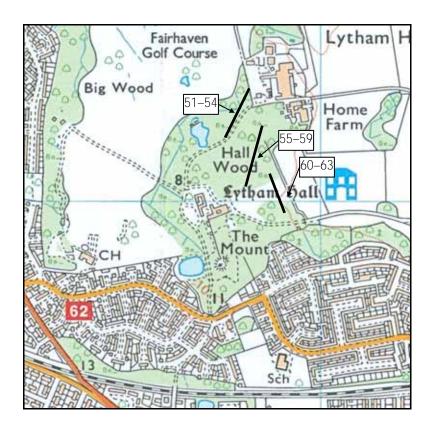
Figure 10: Transect lines used to select oak trees for coring, samples 51-63

The 13 living oak samples from the park were taken along 3 separate transect lines (Figure 10). These cores were prepared for analysis, measured, and the resultant ring series were initially compared with each other. This material is characterised by unusually rapid growth, some trees contain some aberrant growth sequences, and the assemblage as a whole exhibits relatively poor internal cross-matching (Table 10). Sequence LythamOak2 constructed from these, a 193-year composite, matches with other modern reference data (Table 11) at AD 1817 to AD 2009 inclusive. A summary of these results is given in Figure 11. This material was cored on 26 March 2010 and no visible signs of the onset of growth for 2010 were observed at the bark edges of the cores. The trees were not in leaf.

KEY For approximate locations see Figure 10 Bw bark after complete ring.
