RESEARCH REPORT SERIES no. 51-2013

ENGLISH HERITAGE INLAND ESTATE FLOOD RISK ASSESSMENT

SUMMARY

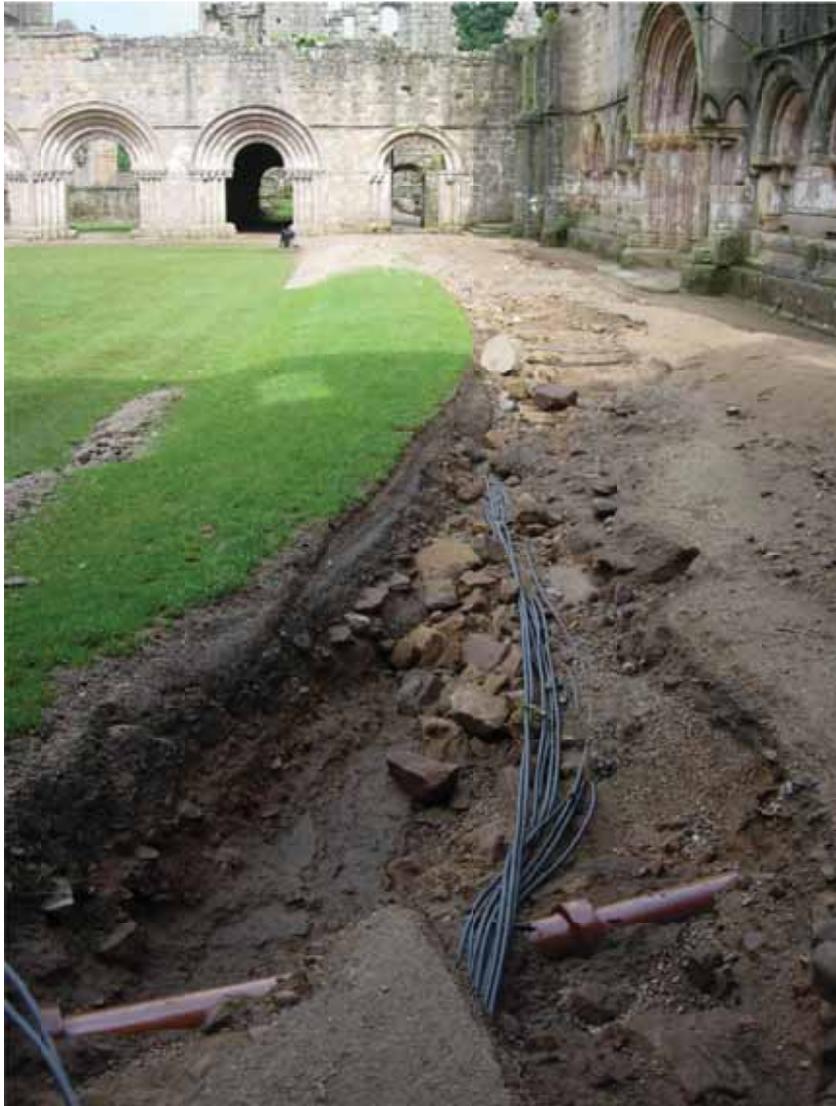
Erosion gullies at Fountains Abbey after the 2007 flood (Neil Redfern)
