# Archaeological Field Survey Report

## BEAUMONT QUAY, BEAUMONT-CUM-MOZE ESSEX

BEAUMONT QUAY,  
BEAUMONT-CUM-MOZE,  
ESSEX

APRIL 1996

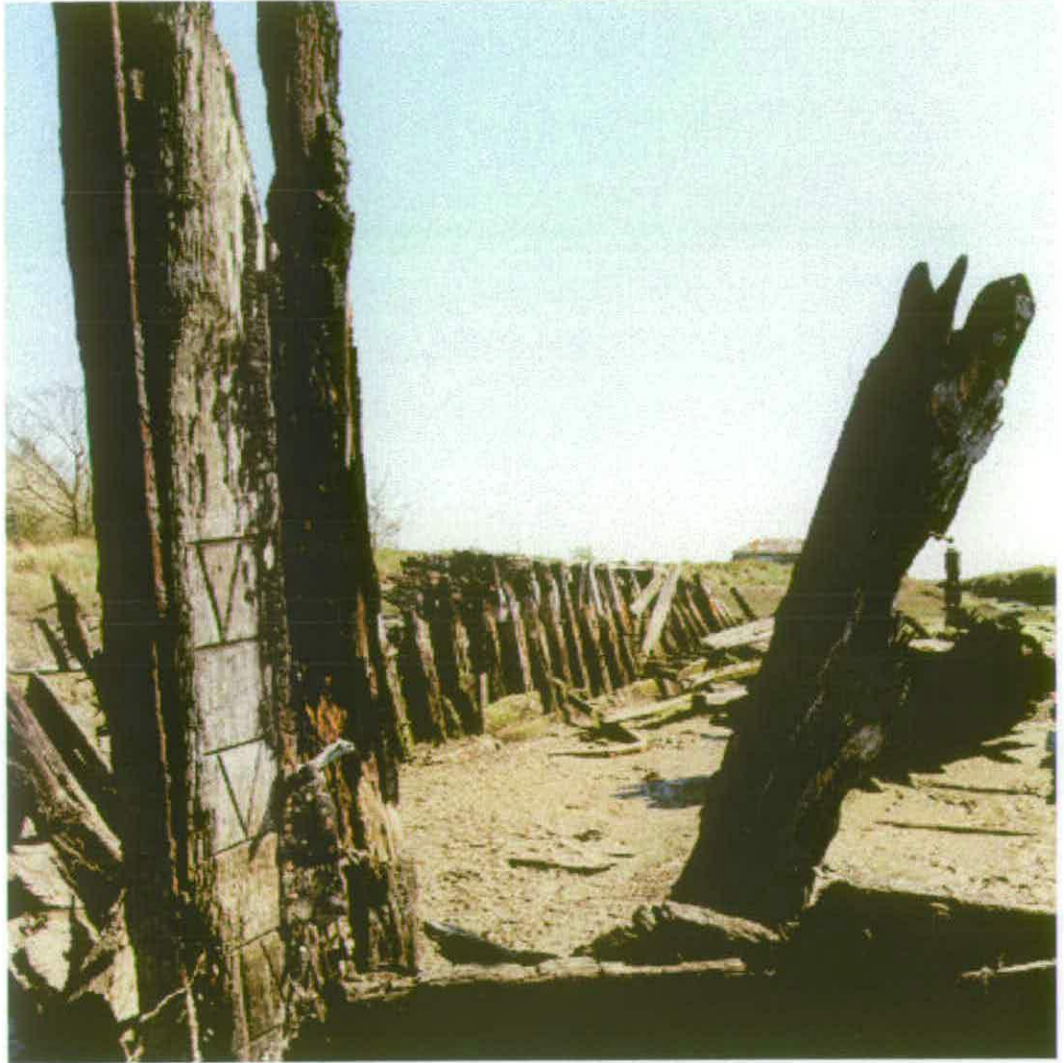
*The wreck of the Rose, a spritsail barge launched in 1880, hulked at Beaumont Quay (NMR AA96/5733)*

Air photographs reveal that the *Rose* came to Beaumont Quay, her final resting place, after 1955 and before 1967 (RAF 58/1672/269-70, 3 March 1955; OS 67/063/16-17, 27 April 1967). The *Rose* was a swim barge spritsail (SMR 14891) of carvel construction built by John Howard of Maldon and launched in September 1880. Her original measurements were 75.3 x 18.6 x 5.5ft (22.95 x 5.67 x 1.68m). She was owned initially by Charles Ward, a miller of Beeleigh Grange, and Charles Hawes/Samuel Thompson, hay merchants of Maldon. Around 1930 she changed hands, becoming a lighter at Heybridge Basin. She was bought around 1961 and towed to Beaumont Quay for conversion into a houseboat but was never fully restored (Perks 1996, 71). The *Rose* is now slowly decaying into the mud, all her

decking collapsed but with much of the lower part of the hull intact, along with the rudder, and the bow and stern posts which retain carvings giving the draught. She lies at the head of the creek in a rectangular area defined by scarp F on the north and a low bank along the southern side: the latter stays dry at high tide and may have provided access to the barge in her last years.

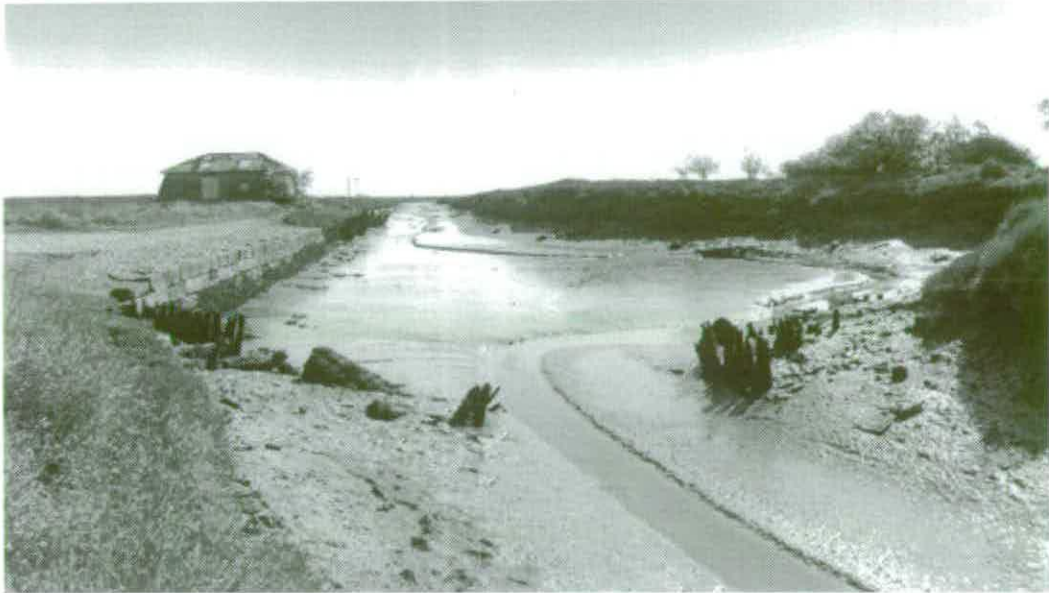
*Figure 7  
Beaumont Quay and  
Beaumont Cut, from  
the west (NMR  
AA96/5743)*

The head of Landermere Creek is encircled by a massive flood embankment up to 14m wide and 3.5m high. The section north of Beaumont Cut is entirely modern, built at the same time as the large drainage cut at its base (see above), as was that part of the western flood bank north of E. When the quay was operational, the flood bank started at E, leading along its present course south then east along the southern side of Landermere Creek. Another lower bank, which survives mainly as a scarp or disturbed bank F, up to 1m high, follows a straight course from E to the quay wall. The tidal flow along Landermere Creek was thus contained by the flood bank and along an east-west line from the quay to E, but separated from Beaumont Cut by G, a prominent bank along the southern side of the Cut, surviving today at 5.0m to 8.0m wide and up to 1.5m high. The tidal flow along the creek and the Cut were regulated by a sluice (Ordnance Survey 1897). The timber remains of the sluice and a footbridge over, can still be seen (Fig 7, foreground).

On its approach to the quay Beaumont Cut is some 12m in width. Its western end has a broad southward loop forming a basin probably intended to facilitate the turning of vessels (Fig 7). The quay, some 80m long in total, was built along the northern bank of the Cut in a straight line, except the eastern end which curves to landward slightly to follow the ground plan of the limekiln. The majority is of timber construction but the western end is in stone. The timber section is essentially a vertical plank revetment held in place by large horizontal

A sluice formerly existed between the end of Beaumont Cut and Landermere Creek (Ordnance Survey 1897). Remains of the timber revetments to the banks on each side of this sluice remain, once more edge-set planking, at best 1m high but on the southern side are some driven stakes which may be part of the footbridge structure (Fig 7).

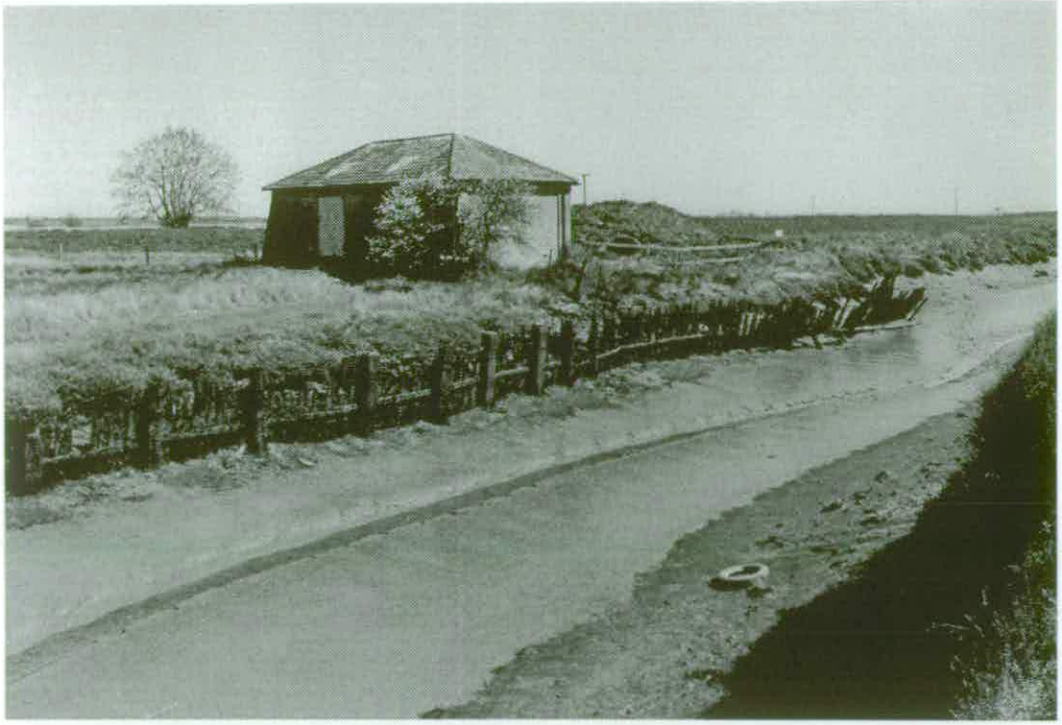
Figure 12:  
Beaumont Quay,  
store building and  
limekiln from the  
south-west (NMR  
AA96/5745)

The limekiln is a circular structure in red brick contained within an earthen mound. The mound itself, badly eroded by rabbit burrowing, measures 12.6m in diameter and stands 2.5m high (Fig 12). The kiln floor is sunk a further 0.5m below ground level and is reached down a flight of four steps and along a short open passage. Access to the kiln is through a segmental arch of four header courses, the top two breaking forward, closed by a wooden door with wooden frame. The interior of the kiln comprises a round, barrel-vaulted circulation passage, 1.55m wide and 2.25m high, around the central pedestal of the combustion chamber, or pot (Fig 13). The passage walls are of mortared brick laid to English bond up to a corbel course of stretchers, from which the vault rises, itself entirely of stretchers. The wall of the passage is pierced on the northern side by a small rectangular opening with shallow segmental arch and internal timber frame: it gives onto a chute leading gently upwards to the exterior of the mound. This feature is probably a ventilator allowing regulation of the draught to the kiln. The pedestal of the pot has an overall diameter of 2.25m and is pierced by three tapping apertures, placed symmetrically from the entrance to the kiln, each a rectangular opening with segmental arched head and sloping sills. These were used for setting the fire, raking off ash and removing the finished lime. The internal base of the pot is c. 1.45m wide, flaring upward through the mound to an open top; the brick rim, 2.2m across, is visible on the summit of the mound but the pot itself is choked with debris.

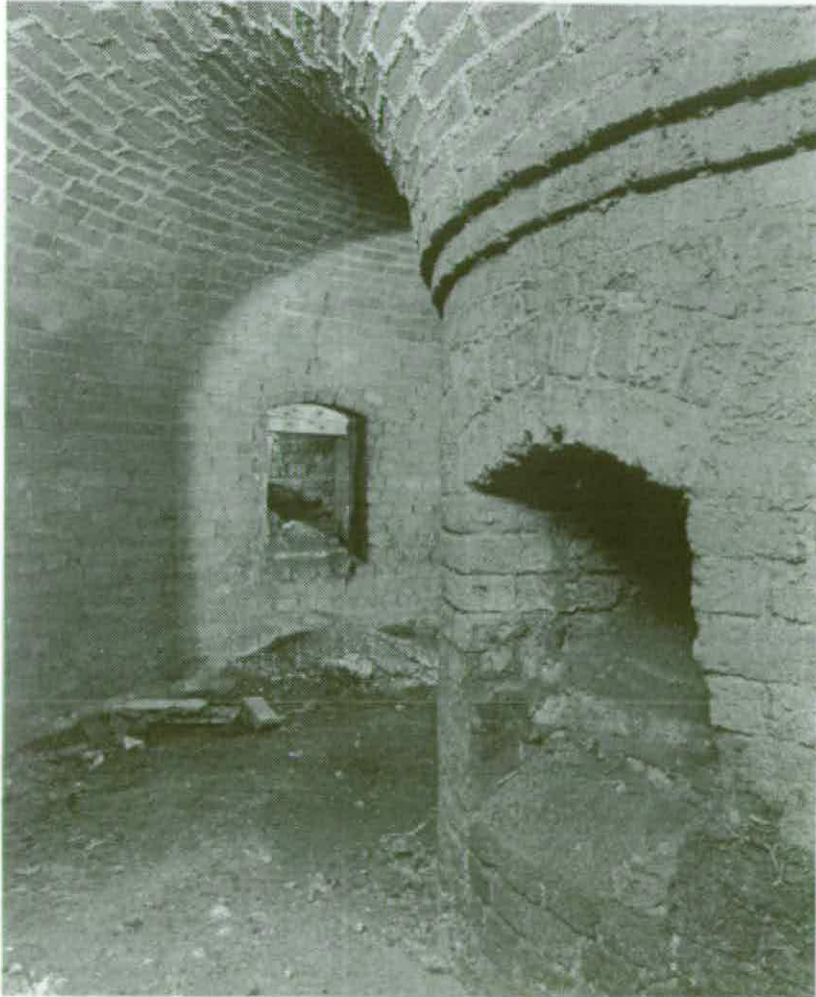
Figure 13:  
Beaumont Quay,  
interior of the limekiln  
with vent (centre left)  
and draw hole (right  
foreground) (NMR  
AA96/5758)

The kiln is of a mixed feed type in which the pot was filled with alternate layers of limestone and fuel. Its careful design may have enabled continuous re-charging and firing for a long period, the vaulted tunnel enabling access to periodically draw off ash and lime, the door and vent regulating airflow. The sunken floor was probably designed to reduce the effort required to load the kiln: at present there is no ramp or other structure visible to enable charging.
